**STORM WATER DRAINAGE STUDY
KNOLLWOOD PARK VILLAS**

January 2021

LAWSON-FISHER ASSOCIATES P.C.
CONSULTING ENGINEERS

**ST. JOSEPH COUNTY SURVEYOR
ST. JOSEPH COUNTY, INDIANA**

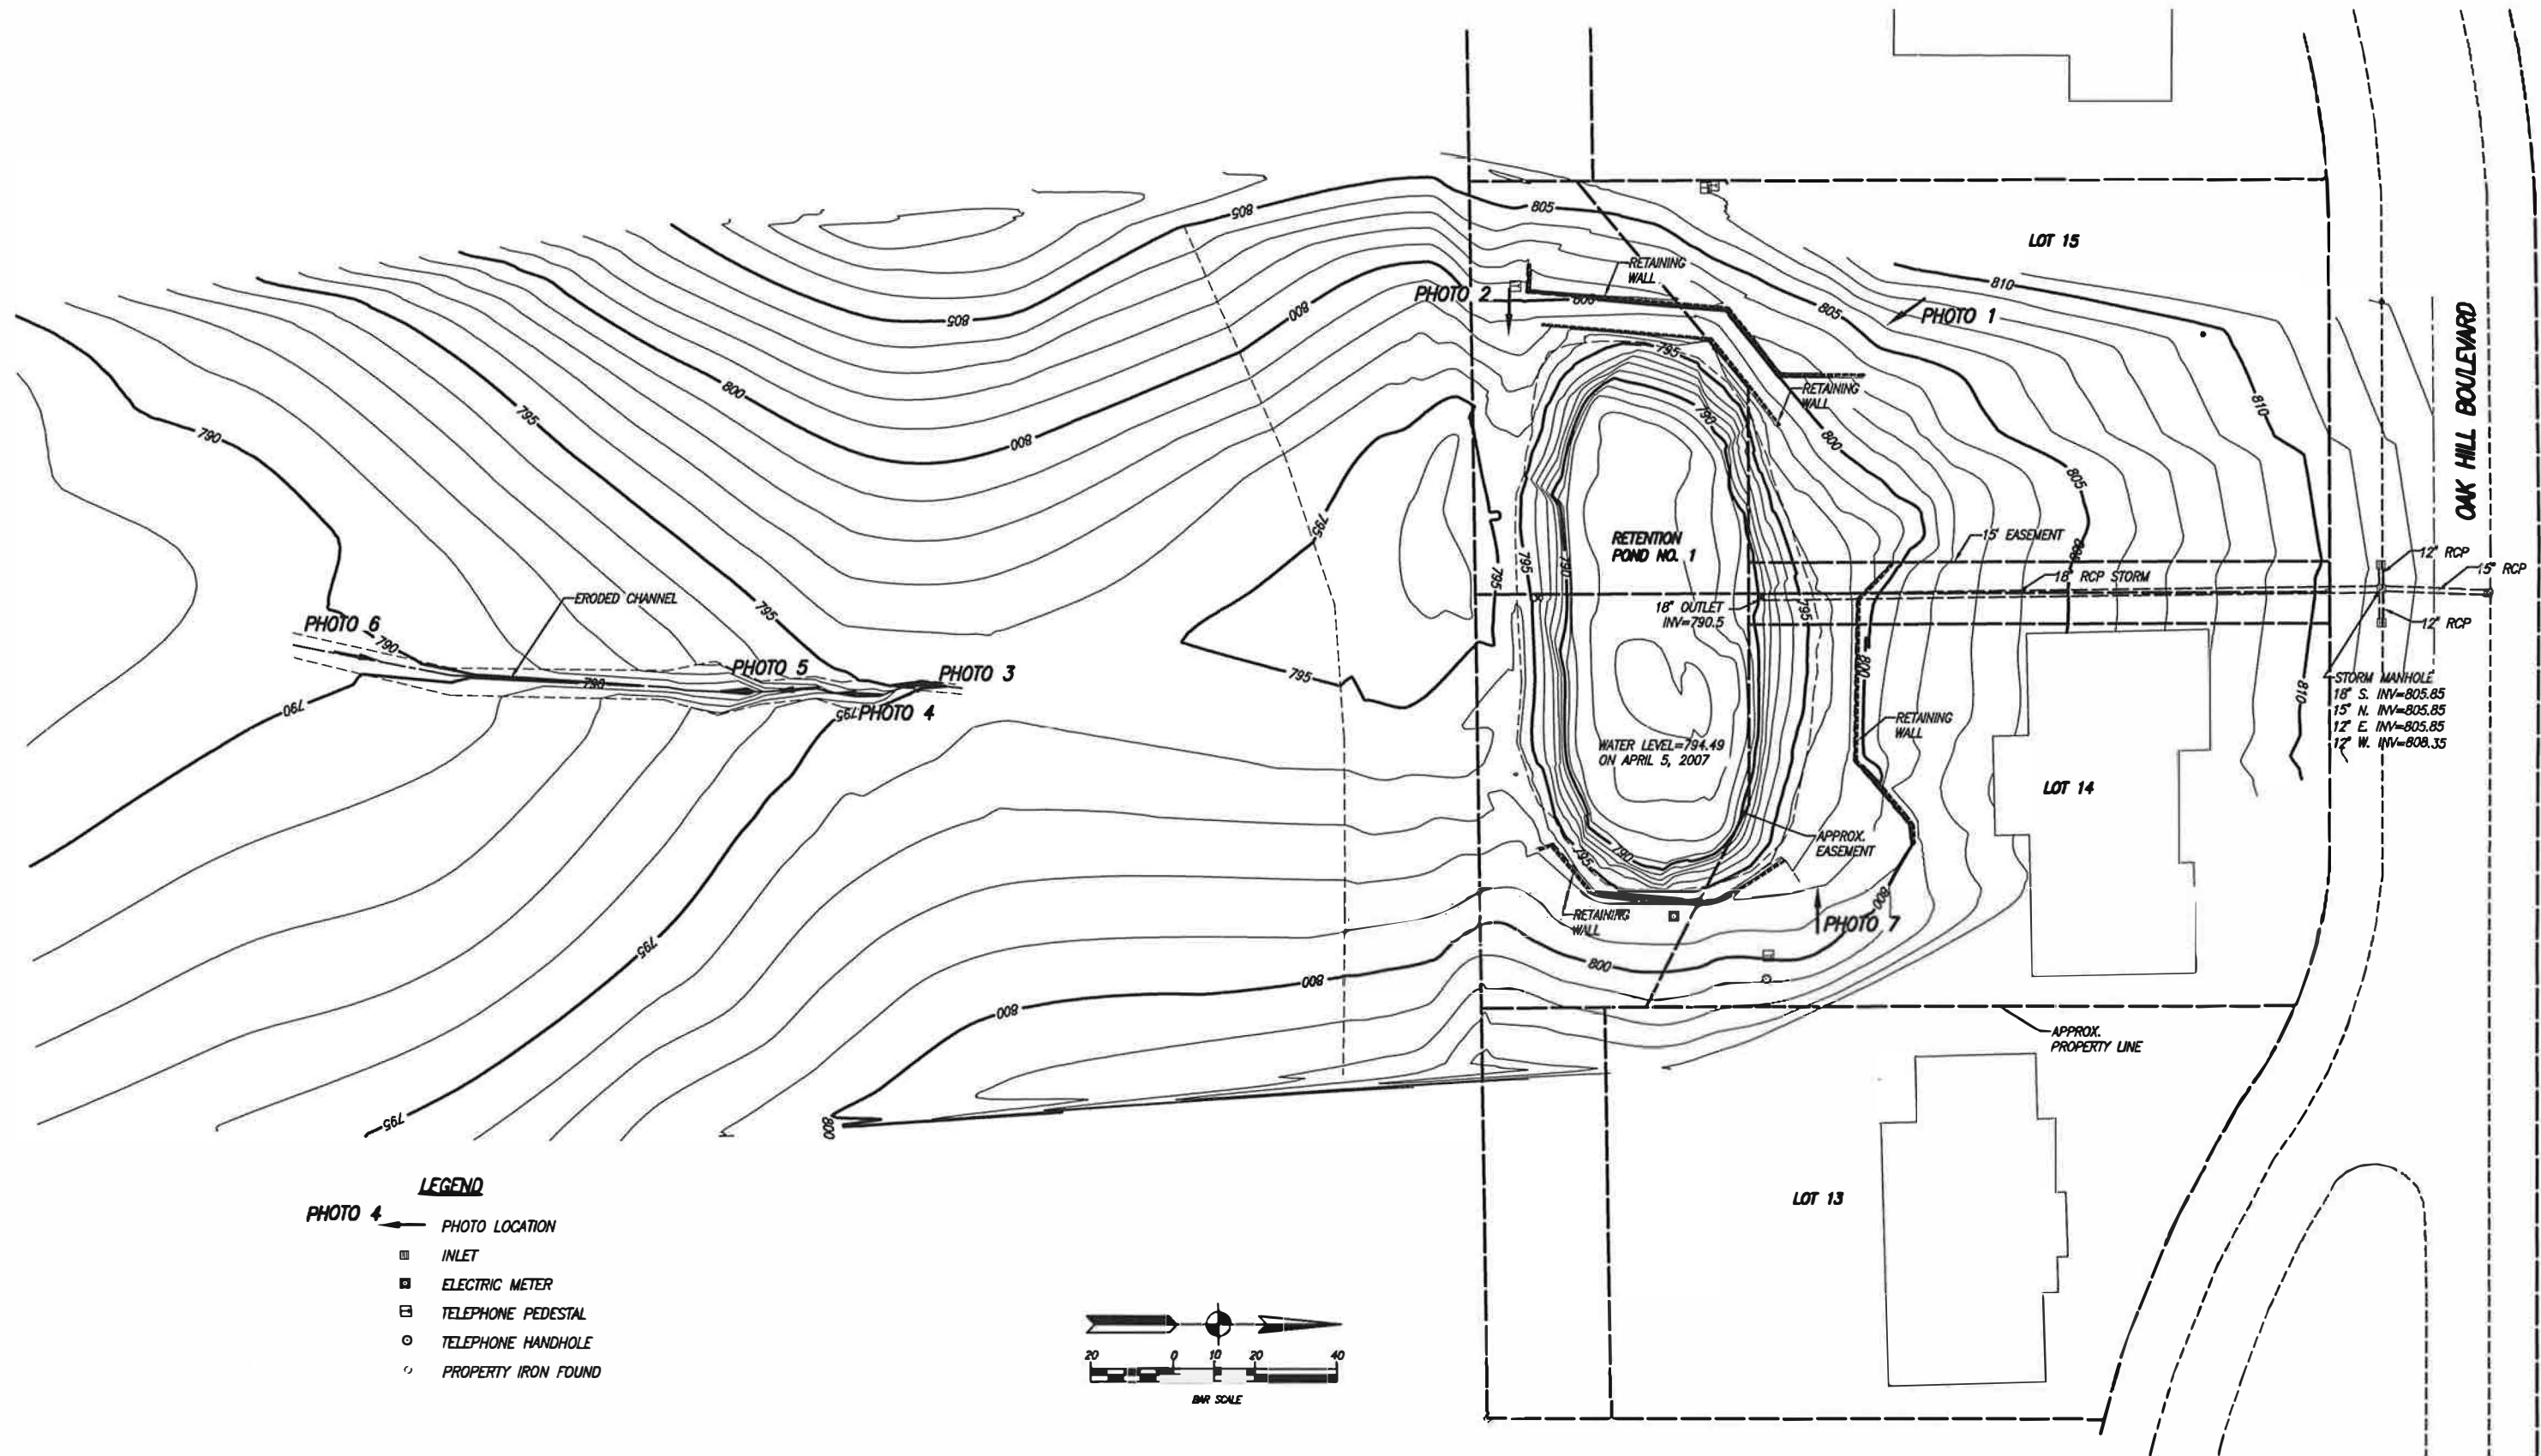
FIGURE 3
 RETENTION POND #1 TOPOGRAPHY

Note: Topography from 2007 Field Survey by LFA.

Retention Pond #1 located across Lots #14 and #15 has a storage volume of approximately 24,600 cubic-feet, compared with the required storage volume of 341,914 cubic-feet, as reported in LFA's 2007 study. According to the XPSWMM model, the volume of overflow from Retention Pond #1 into the Gumwood Road Retention Pond is 444,970 cubic-feet. Additionally, the volume of runoff contributing to the Gumwood Road Retention Pond from the Gumwood Road Expansion plus the offsite agricultural area is 227,140 cubic-feet. According to the 2013 plans, the 100-year high water level for the Gumwood Road Retention Pond is 795.91-feet, which corresponds to an available capacity of 543,618 cubic-feet (12.48 acre-feet), and a depth of 6.91-feet. Combined with the overflow from The Knollwood Park Villas Subdivision predicted by the XPSWMM model, the total volume required to capture the 100-year 24-hour excess runoff is 672,110 cubic-feet. This results in a high-water level in the existing pond of 796.74-feet, at a depth of 7.74-feet. This elevation is above the high-water level of the 2013 plans, which results in a freeboard of 1.17-feet (less than the 2-feet required), but still within the

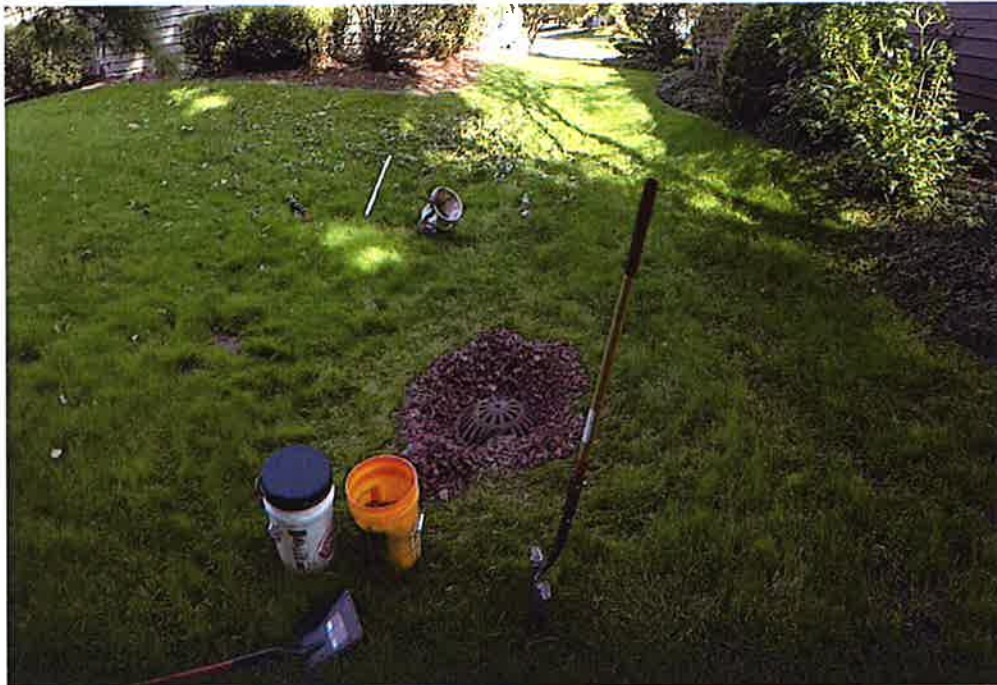
A field survey was conducted in September 2020 throughout the subdivision to confirm drainage patterns. Detailed data was gathered for the existing storm manholes and inlets in the subdivision. Data collected includes rim elevation, invert elevation, pipe size, and material. Field observation of the Lot #19 drywell indicate it is located in an area that is not conducive to flow as it is lower than the storm water detention easement swale, effectively ponding excess storm water that exceeds the drywell capacity.

Photograph 1: Lot #19 Drywell

Based on the modeling results, it is recommended to plug the existing storm sewer that conveys flow to the drywell on Lot #19 to block runoff from entering the drywell and alleviate flooding. This option will cause a slightly higher runoff to flow to Retention Pond #1 and subsequently overflow to the Gumwood Road Retention Pond. If this storm sewer were to be left in operation, flooding would continue to occur on Lot #19. Furthermore, the drywell does not appear to offer any considerable storm water conveyance or storage benefit. Additionally, the soil type in the area of the drywell does not provide adequate infiltration capacity for the drywell to drain thereby minimizing storage capacity for future storms and causing flooding.

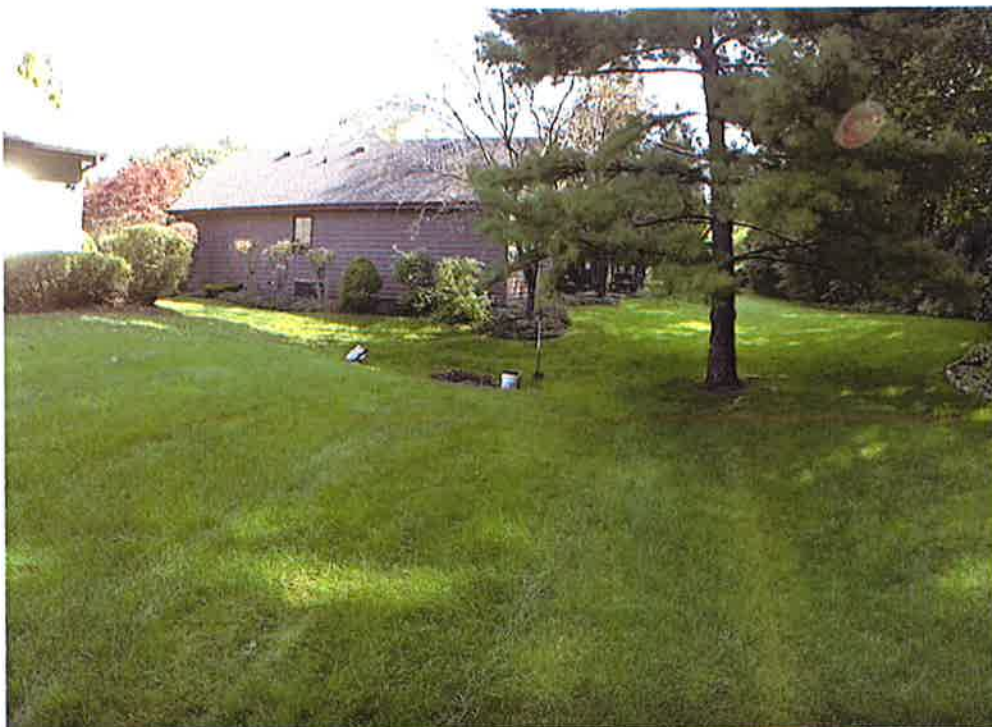
Photograph 2: Drywell Location in Swale

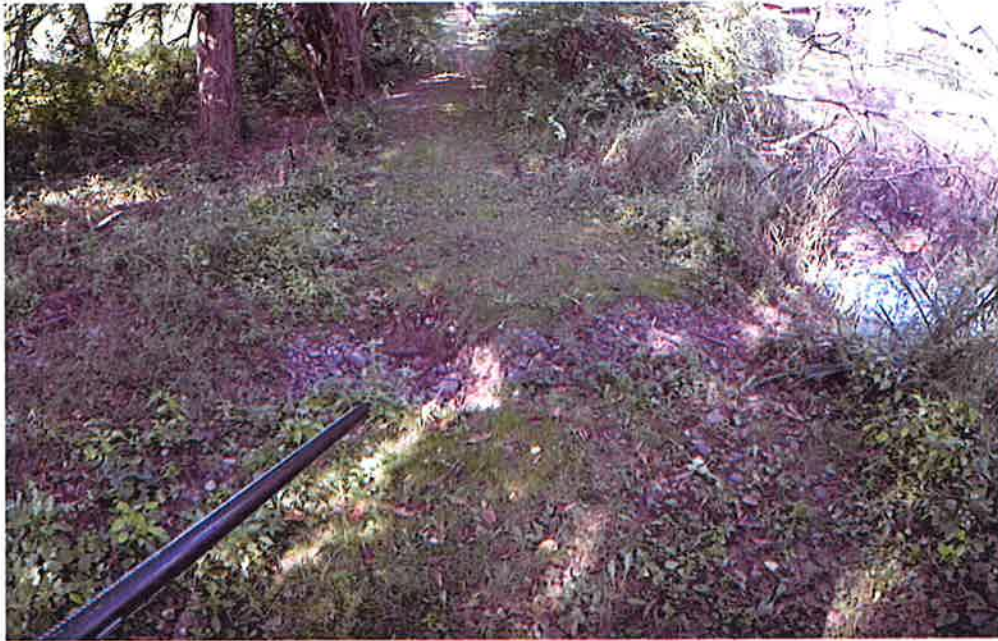
The Gumwood Retention Pond has a riprap channel, approximately 56-feet long, which receives overflow from Retention Pond #1 in Knollwood Park Villas. This riprap does not appear to be performing as intended due to erosion. See accompanying photographs in Appendix C. The day of the field survey, the water level in Retention Pond #1 was 794.3-feet with a vegetation line equivalent to 794.8-feet. The riprap channel water level was 791.9-feet with a vegetation line at 792.4-feet. Retention Pond #1 and the riprap channel leading to the Gumwood Road Retention Pond left little storage available according to vegetation lines and actual water lines. The riprap section had heavy brush covering the path and erosion as shown in the survey photographs in Appendix C. The Gumwood Road Retention Pond was shown as partially full and had partially flowed through the boundary fence to hold the water contained. Anecdotal data from a nearby resident indicated that the Gumwood Road Retention Pond is always at the same level as shown in Photograph 6 of Appendix C and does not fluctuate dramatically. Preceding the LFA survey, was a sunny day without precipitation.

**Photograph 3: Beginning of Rip Rap Overflow from
Retention Pond #1 to Gumwood Road Retention Pond**

- Install three new drywells at the bottom of the basin, penetrating through to the sandy soils, to allow infiltration and draining of the pond
- Install an 18-inch-thick layer of riprap for erosion control on the side slopes around the perimeter of the basin and around the top perimeter of the new drywells in the bottom of the basin.

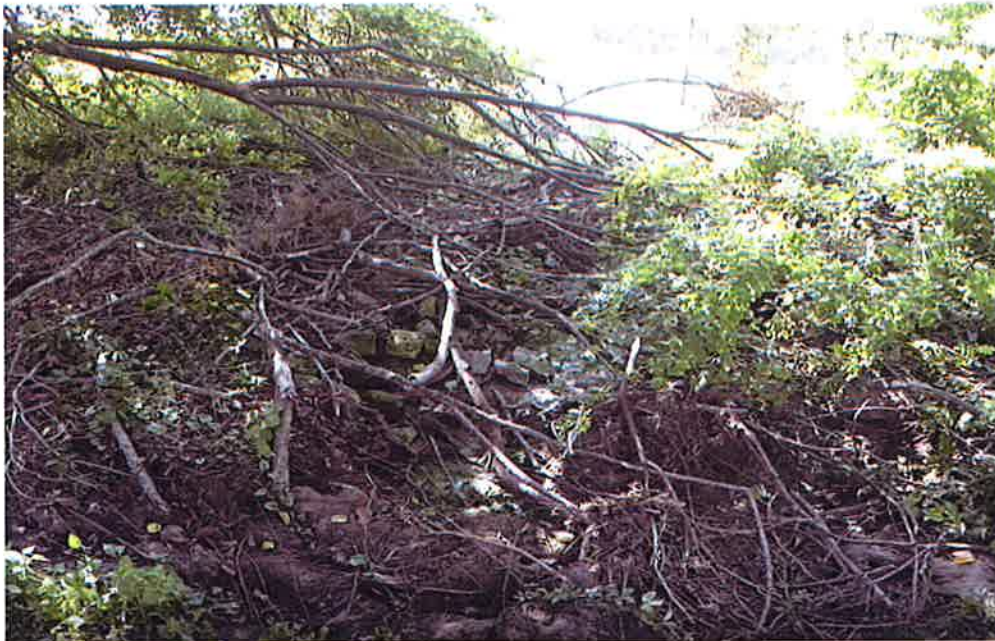
**Photograph 4: Rip Rap Lined Overflow from
Retention Pond #1 to Gumwood Road Retention Pond**

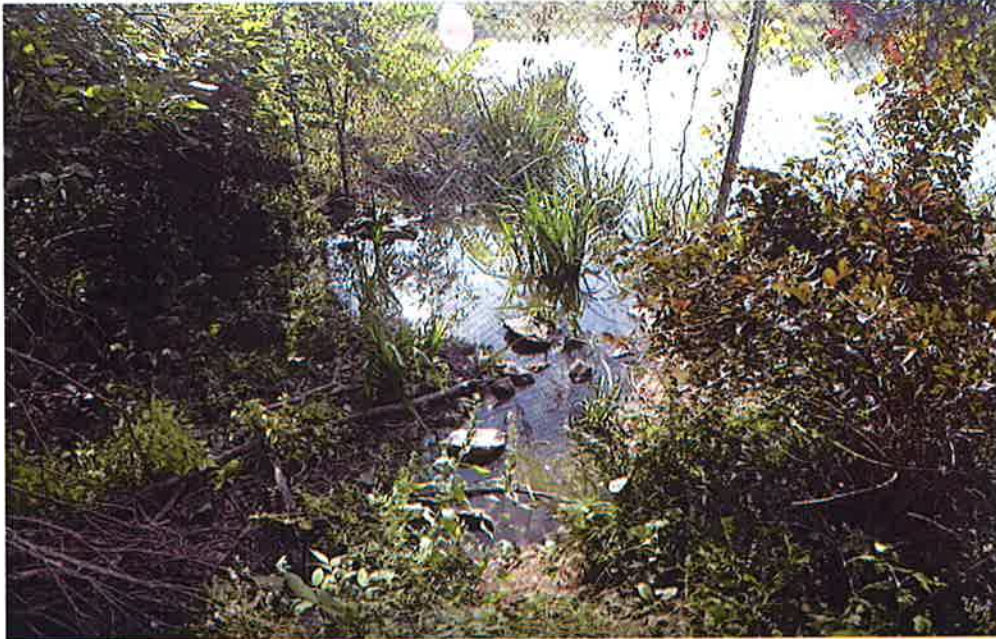
Photograph 5: Overflow into Gumwood Road Retention Pond

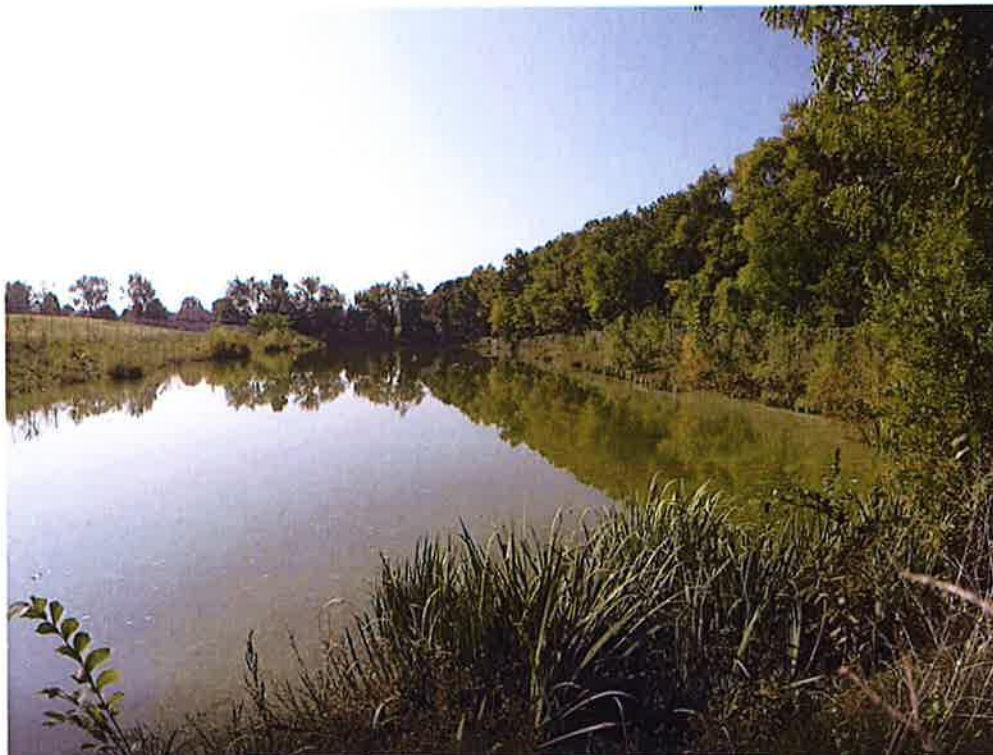
The existing Gumwood Road Expansion Pond, has sufficient storage capacity to retain the excess storm water flows from The Knollwood Park Villas Subdivision, as designed, combined with excess runoff flows from the Gumwood Road Expansion, however, the Gumwood Road Retention Pond is not infiltrating effectively and a 2-foot freeboard requirement would not be met with excess storm water flows. While it is uncertain why the drywell was installed in the rear of Lot #19, the modeling indicates that plugging the pipe leading to this drywell may resolve flooding concerns. It should also be noted that according to the model, the rest of the storm water conveyance network within the subdivision, including the ponds, appear to be performing adequately. There is no predicted surcharging of the storm sewers for the 10-year storm, no flooding above the rim elevation for the 50-year storm, and all overflows from ponds appear to be directed to Retention Basin #1 and ultimately to the Gumwood Road Retention Basin.

Photograph 6: Gumwood Road Retention Pond Water Level

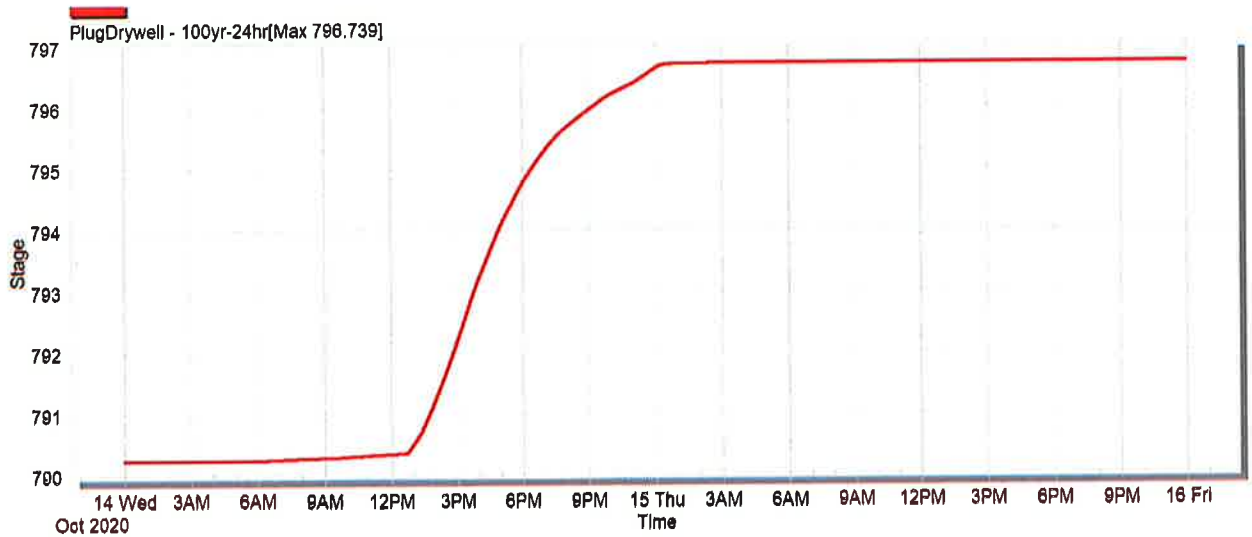
Graph 1: Plug Pipe to Drywell, Retention Pond #1

Table 2 summarizes the existing pond capacity compared to the modeled pond performance with the recommended improvements. While the Gumwood Road Retention Pond appears to have sufficient storage capacity to retain runoff from the 100-year, 24-hour storm for the contributing areas of The Knollwood Park Villas Subdivision and Gumwood Road, the 2-foot freeboard allowance is not being met. An expansion of the Gumwood Road Retention Pond by approximately 128,500 cubic-feet is recommended in order to meet current County standards. Graphs 1 through 4 in Appendix D show the differences in pond elevations for the 100-year, 24-hour storm both with and without the drywell plugged.

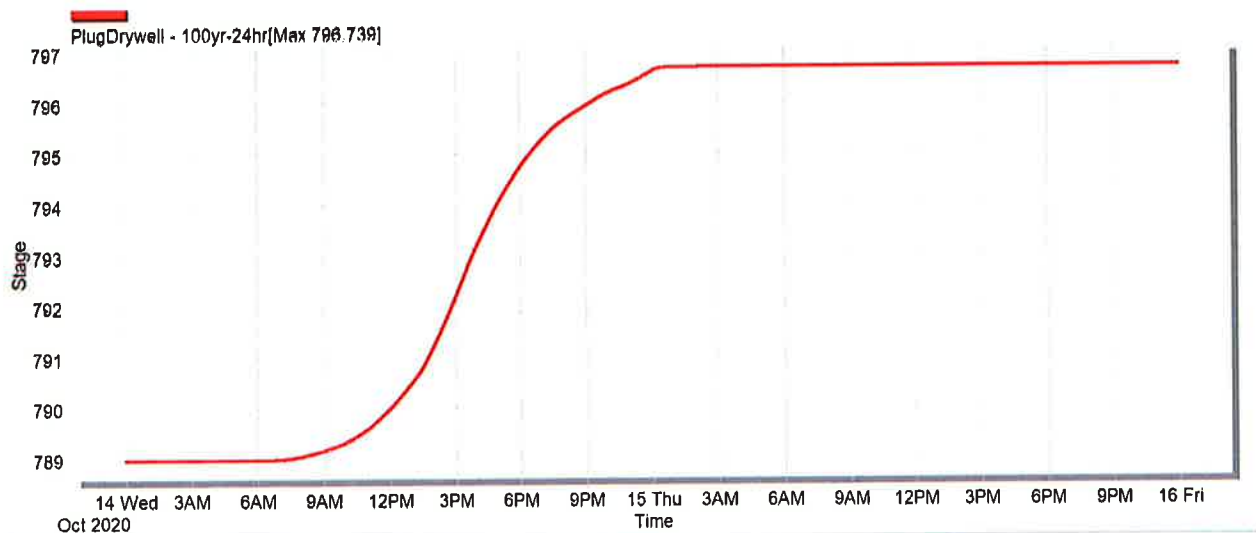
Graph 2: Plug Pipe to Drywell, Gumwood Road Retention Pond

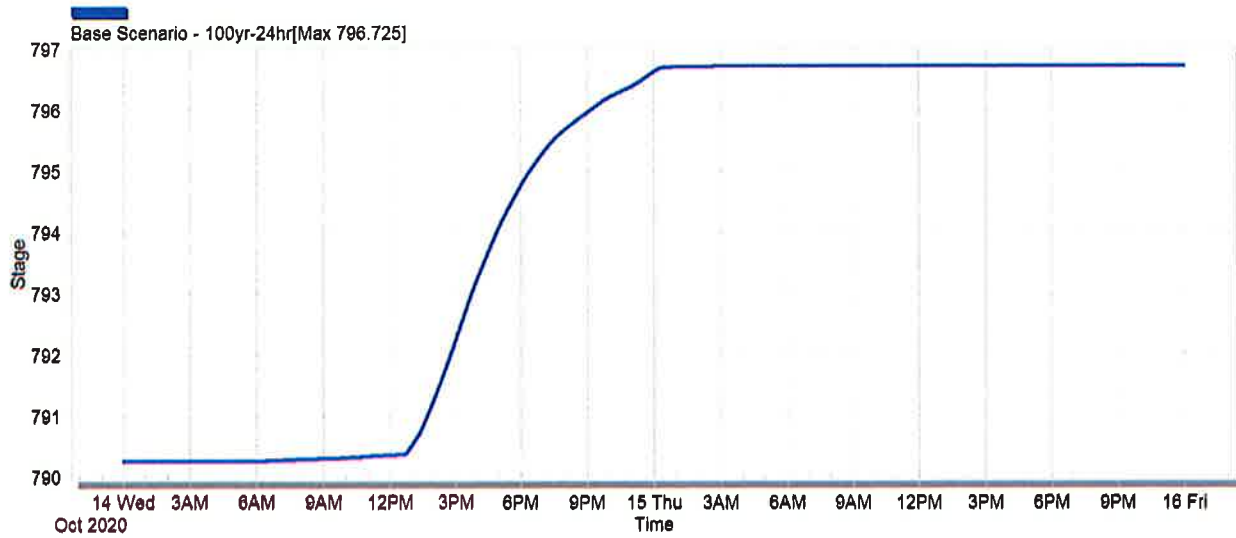
Graph 3: Leave Pipe to Drywell As-Is – Un-Plugged, Retention Pond #1

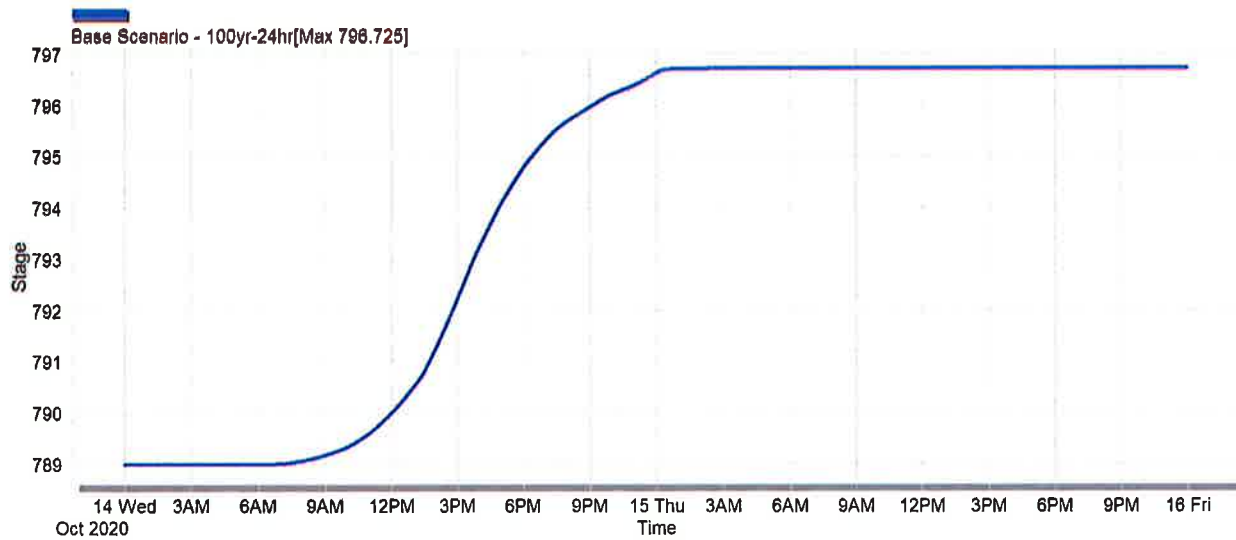
Graph 4: Leave Pipe to Drywell As-Is – Un-Plugged, 2013 Retention Pond
